Manhole Inspection Summary

Manhole # S51C__032MH

Insp Date: **5/2/08 9:27 AM**

Location Address: **139 n kenwood ave**

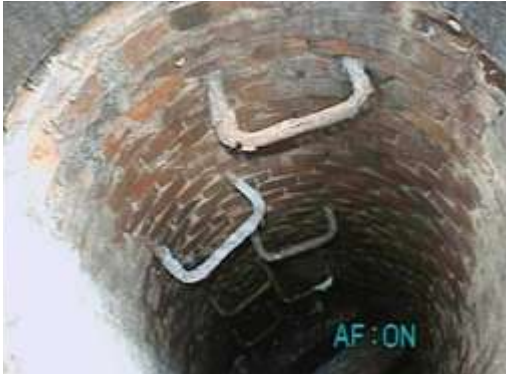
Defect 1

Count: **7** Missing: **0** ☒ **Corroded**

bench debris

steps

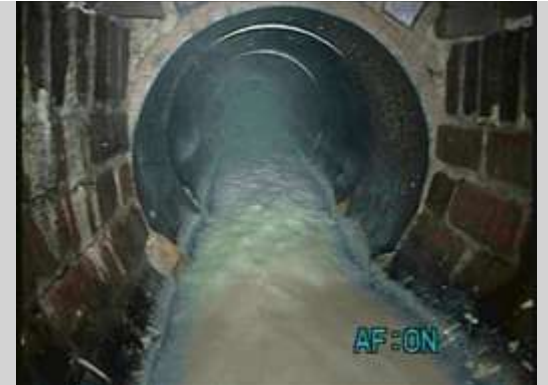
12 O'Clock Outflow

18 in. Circular Gravity Sewer
Pipe Out @ 12 O'Clock

Infiltration: **None** Pipe Seal Cond: **Sound**

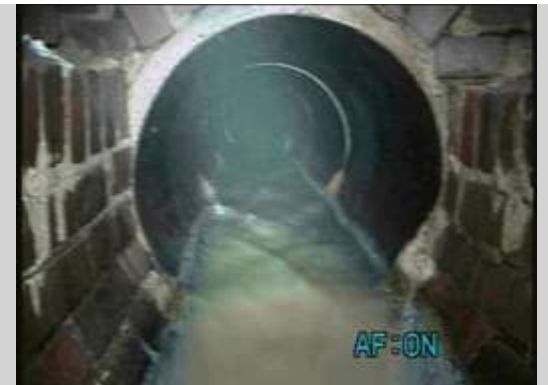
6 O'Clock Inflow

18 in. Circular Gravity Sewer
Pipe In @ 6 O'Clock

Infiltration: **None** Pipe Seal Cond: **Sound**
